The Application of Qualification Testing, Field Testing, and Accelerated Testing for Estimating Long-Term Durability of Composite Materials for Caltrans Applications

G. L. STECKEL and G. F. HAWKINS
Space Materials Laboratory
Laboratory Operations

STATE OF CALIFORNIA
DEPARTMENT OF TRANSPORTATION
Sacramento, CA 94273

Contract No. 59A088

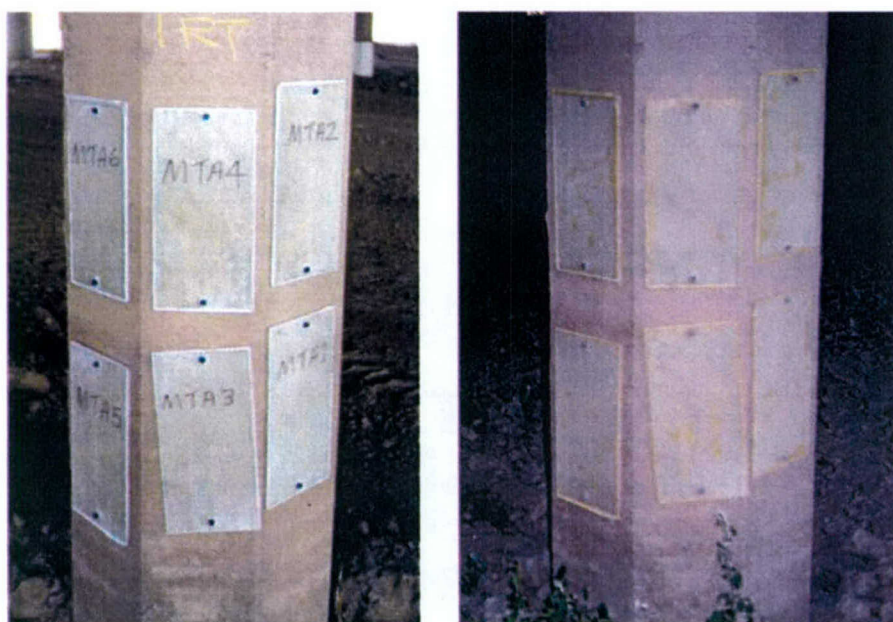
Figure 2.3. Photographs of Myers Technologies, Inc. E-glass/Polyester/MOR-AD-695-28 Adhesive-bonded assemblies taken at beginning (left) and after 1-yr field exposure.

Comparative photographs taken immediately after mounting the panels on the columns in October 1998 and after the first year of exposure in September 1999 are shown in Figures 2.2 and 2.3 for one carbon-fiber-reinforced system and one glass-fiber-reinforced system. The effects of wintertime flooding and subsequent drying are evident by cracking of the soil around the columns in the one-year photographs. The panels were obviously soiled from the one-year exposure. Sample identification numbers were obscured or removed from several panels, particularly the E-glass/polyester panels fabricated by Myers Technologies, Inc. However, there was no evidence of physical damage to any of the composite panels following the first year of exposure. The photographs in Figures 2.2 and 2.3 are representative of composite systems fielded in the experiment. Photographs for all nine systems are documented elsewhere.¹⁹
